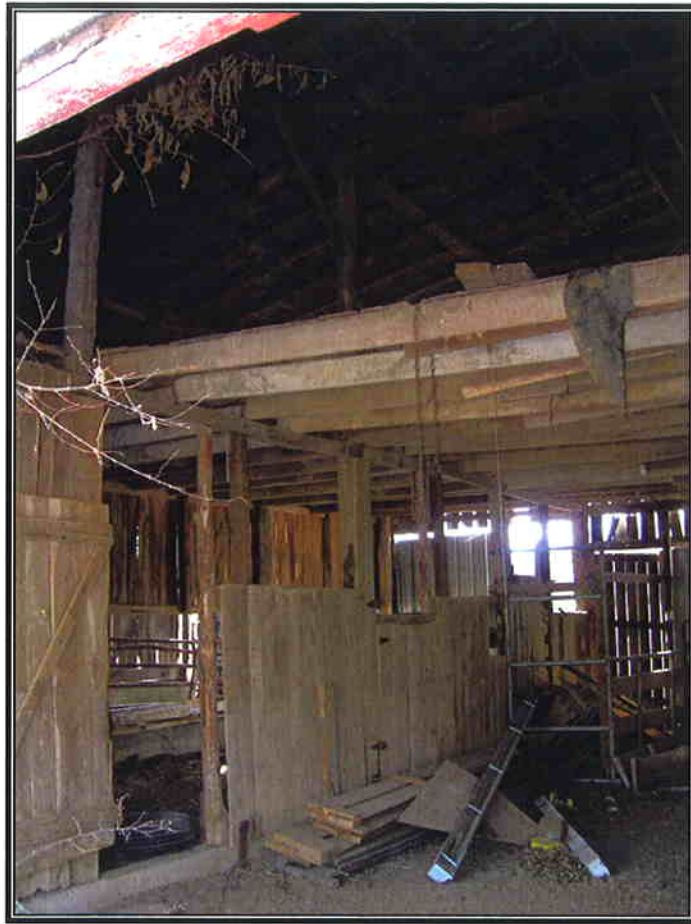
The construction of the barn is much like a pole barn, with tree trunks and sawn lumber serving as vertical and horizontal members (Figure 80). The roof of the barn is sheathed in metal. The barn is clad in vertical boards and rests on a poured concrete foundation. A small, three-bay (w/d/w), side-gable, frame outbuilding is located to the west of the barn adjacent to a pond (Resource R) (Figure 81). The façade has a centered single-leaf entry flanked by windows with two-over-single double-hung sashes. The door is leaning against an interior wall. No lights remain in the sashes. The interior walls are sheathed in bead boards. The outbuilding has exposed rafter tails. The roof, which is partially in ruinous condition, is sheathed in asphalt shingles (Figure 82). Portions of the weatherboard siding are also missing. The outbuilding appears to rest on grade.

Figure 80. Site 3, Interior of barn.

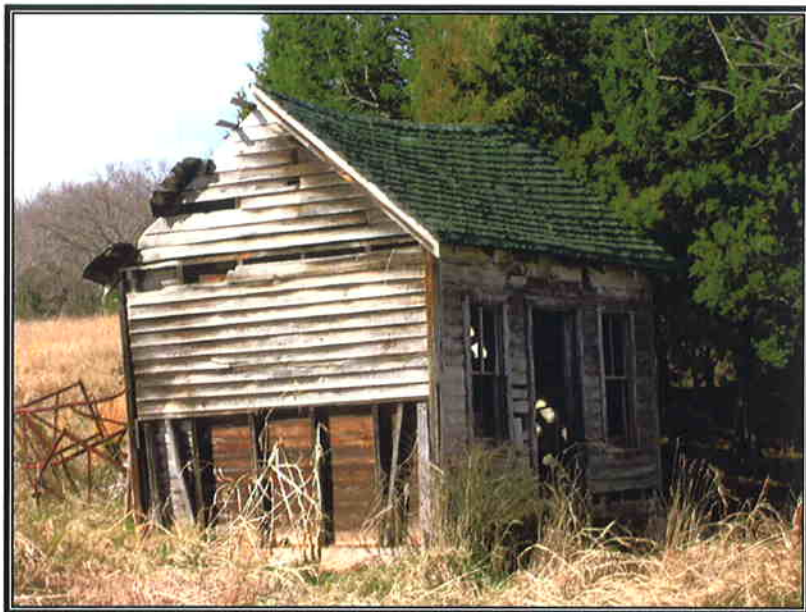
Figure 81. Site 3, One-story, three-bay, side-gable, frame outbuilding (Resource R).

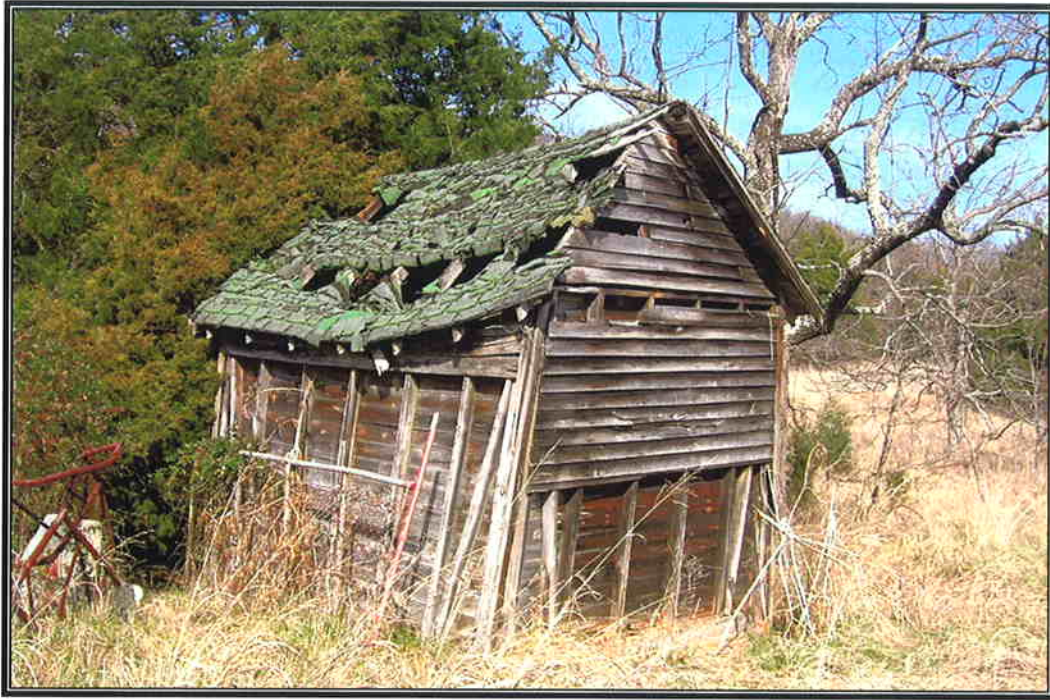
**Figure 82. Site 3, Southeast and rear elevations of the outbuilding.**

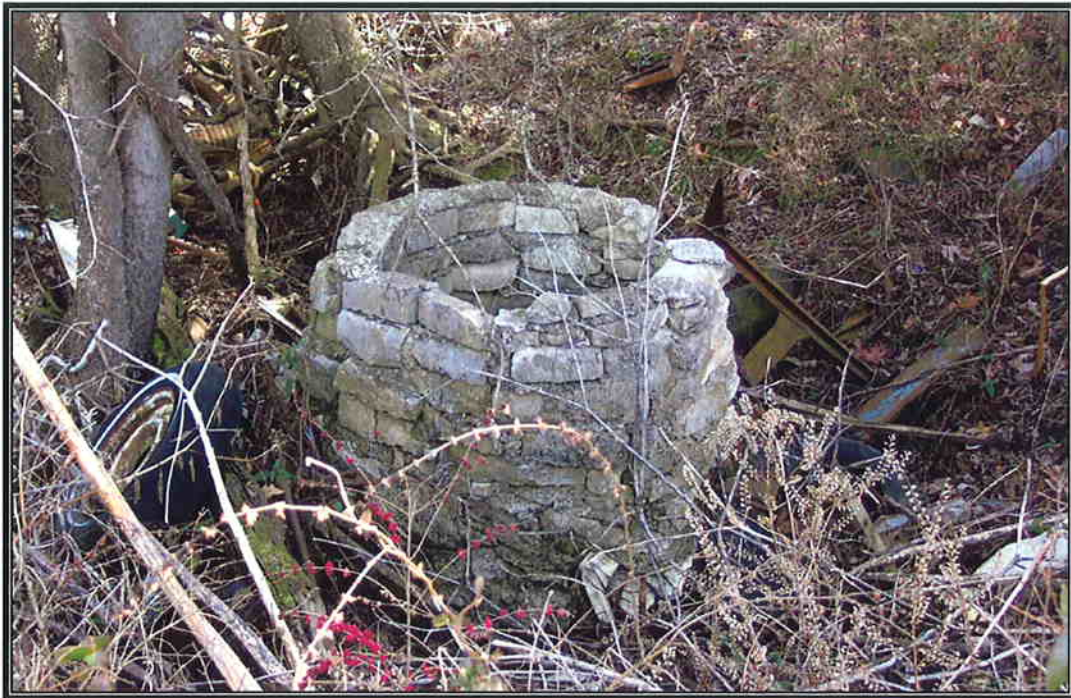
Some distance to the southwest from the small outbuilding and barn is a depression along a fence line. Located in the depression similar to a sink hole is an exposed round structure constructed of mortared stone (Resource S) (Figure 83). This structure appears to be a well, as the interior continues below grade. Southwest and a short distance from the well is a cemetery (Resource T) that according to Emily Perkins Sharp was associated with a non-extant church, the Union Grove Church. According to Sharp, Stephen Perkins and his wife Joanna Perkins are buried in the cemetery. Sharp also states that Joseph Price Perkins, who constructed the main residence on this site, his wife and a number of children are buried in the cemetery (Sharp 2006:n.p.). The cemetery is overgrown with trees and ground cover (Figures 84 and 85). A wire fence crosses through the cemetery. A pedestrian survey of the cemetery indicates only a few visible headstones and footstones. Some of the stones are broken or leaning against trees. Some of the stones were not legible. A number of unidentified and unmarked interments could be located in the cemetery. The legible surnames in the

**Figure 83. Site 3, Probable stone well (Resource S).**

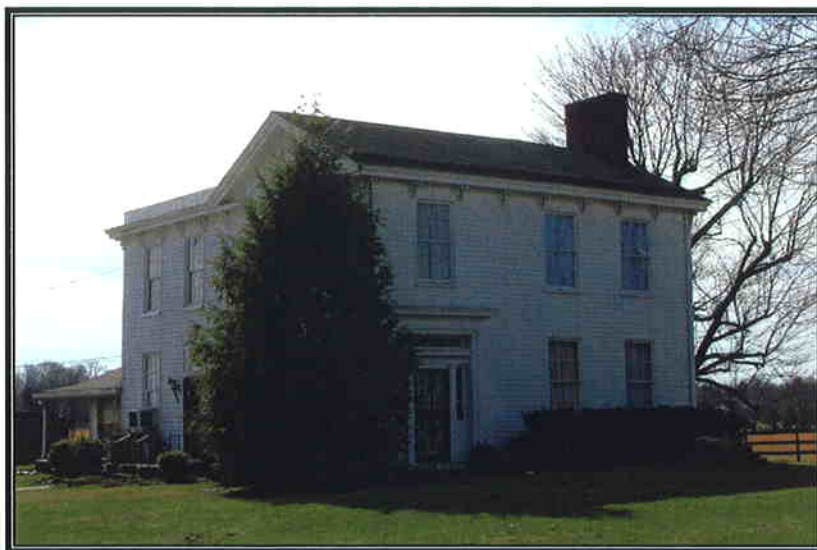
**Description:** This is a two-story, three-bay (d/w/w), side-gable, frame side-passage house historically known as the Gladdish-Asher House (Figure 87). The house, oriented to the northwest, is located at 6309 Russellville Road (US 68). The single-leaf entry is the left bay along the façade. The entry surround has Greek Revival characteristics, with three-light side-lights, a four-light transom, pilasters, and dentil molding above the door and along the frieze (Figure 88). Windows throughout the house have six-over-six double-hung sashes. The southwest elevation has a wide brick chimney flush with the wall plane centered with the gable (Figure 89). A two-story, gable-roof ell extends from the rear of the house forming a continuous wall plane along the southwest elevation. Centered along the rear elevation of the ell is an exterior brick chimney (Figure 90). A two-story addition with a flat- or shallow

Figure 87. Site 4, Two-story, three-bay, side-gable, frame side-passage house (WA-132).

**NRHP Evaluation:** Eligible. According to the files of the KHC, this site was previously determined eligible for listing in the NRHP by agreement. The agreed upon boundaries and

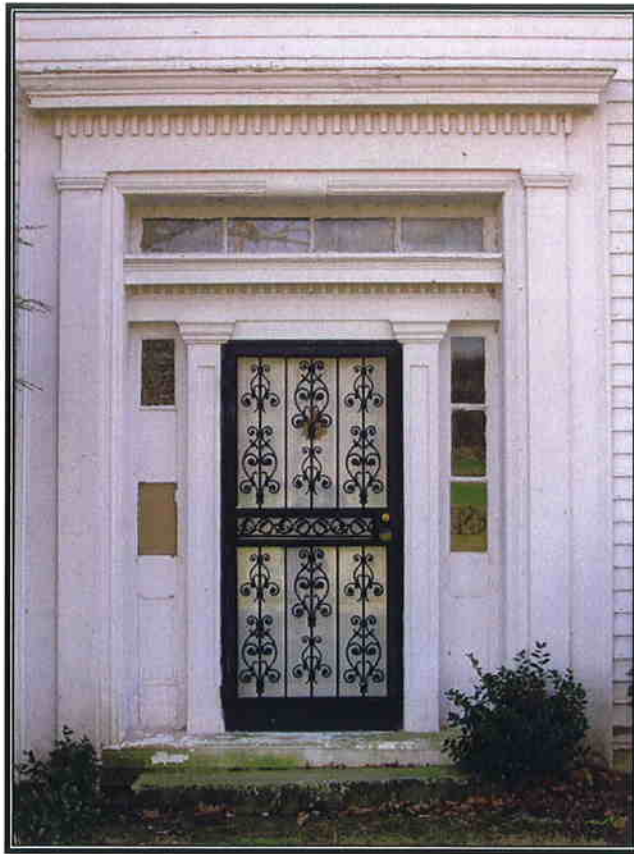
Figure 88. Site 4, Detail of entry.

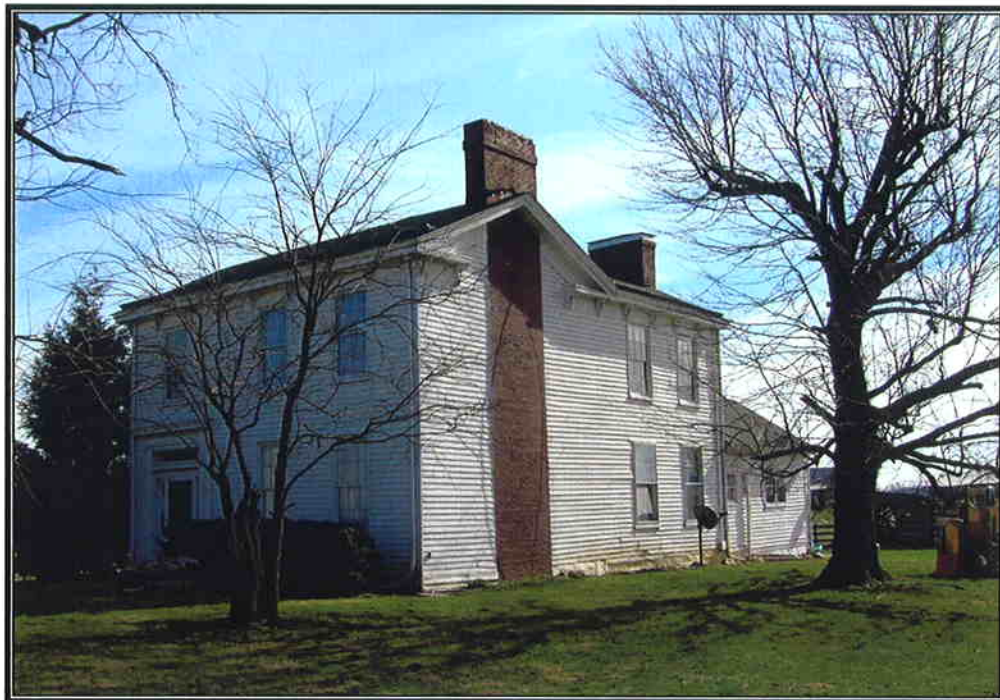
Figure 89. Site 4, Façade and southwest elevations of the house.

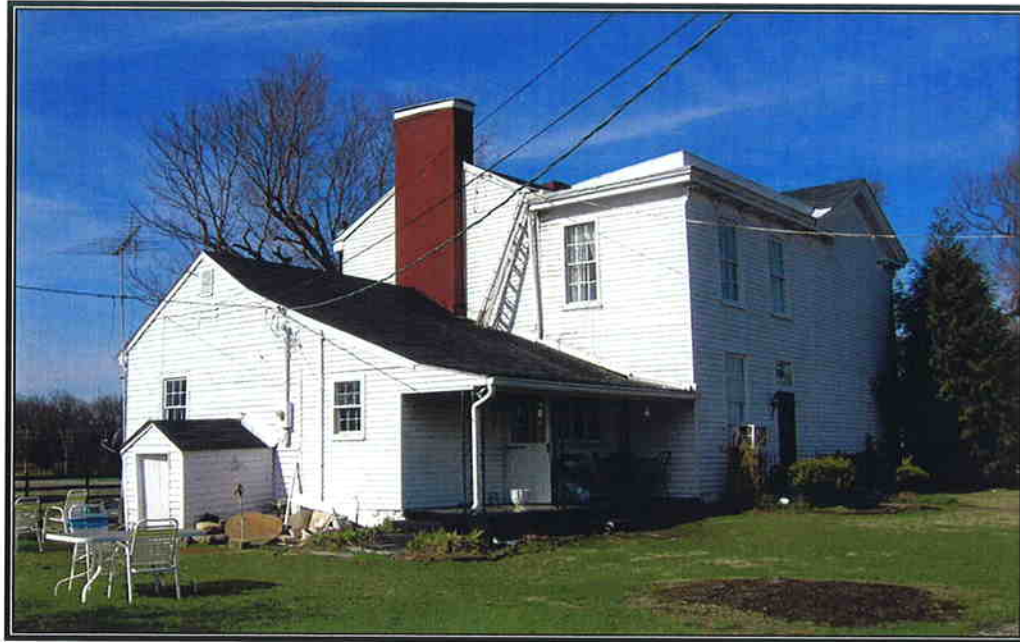
**Figure 90. Site 4, Northeast and rear elevations of the house.**

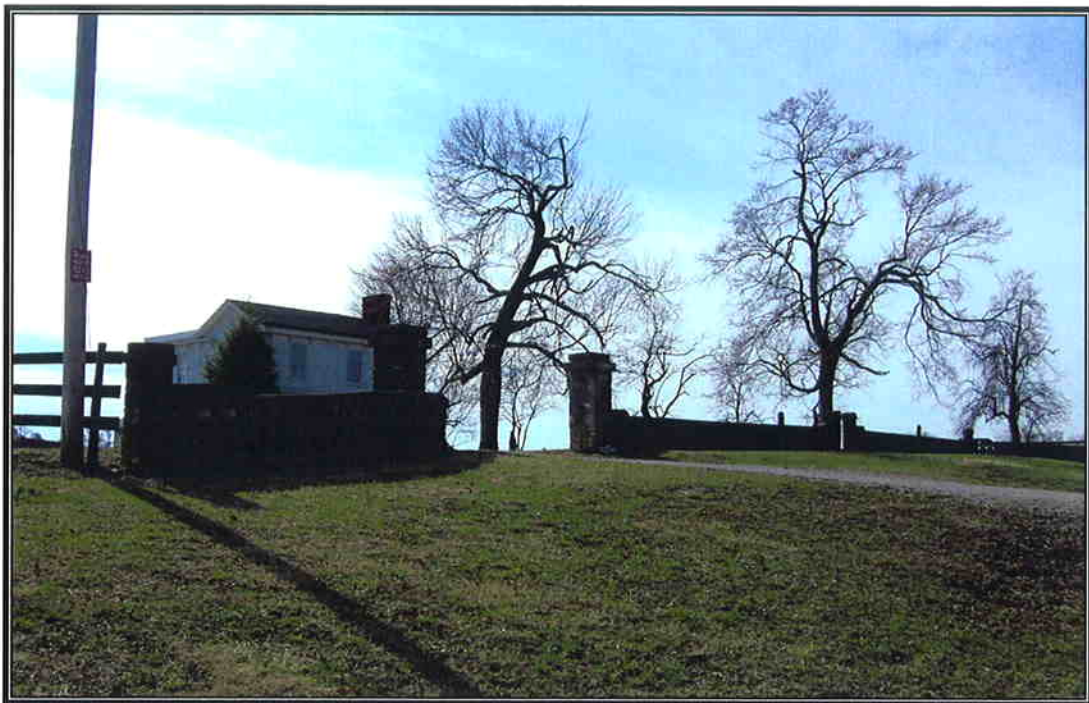
Six outbuildings, former wells, and a historic fence are associated with this site. The historic stone fence extends the width of the domestic yard between the house and Russellville Road (US 68) (Figure 91). The cut stone is laid with large stones along the ground, a narrower cap stone, and filled with a honeycomb pattern between. End posts and gate posts for the drive entry are constructed of stone, as are the pedestrian entry posts. Two stone hitching posts are found along the front of the fence (Figure 92).

Figure 91. Site 4, Historic stone fence along front of domestic yard looking southwest.

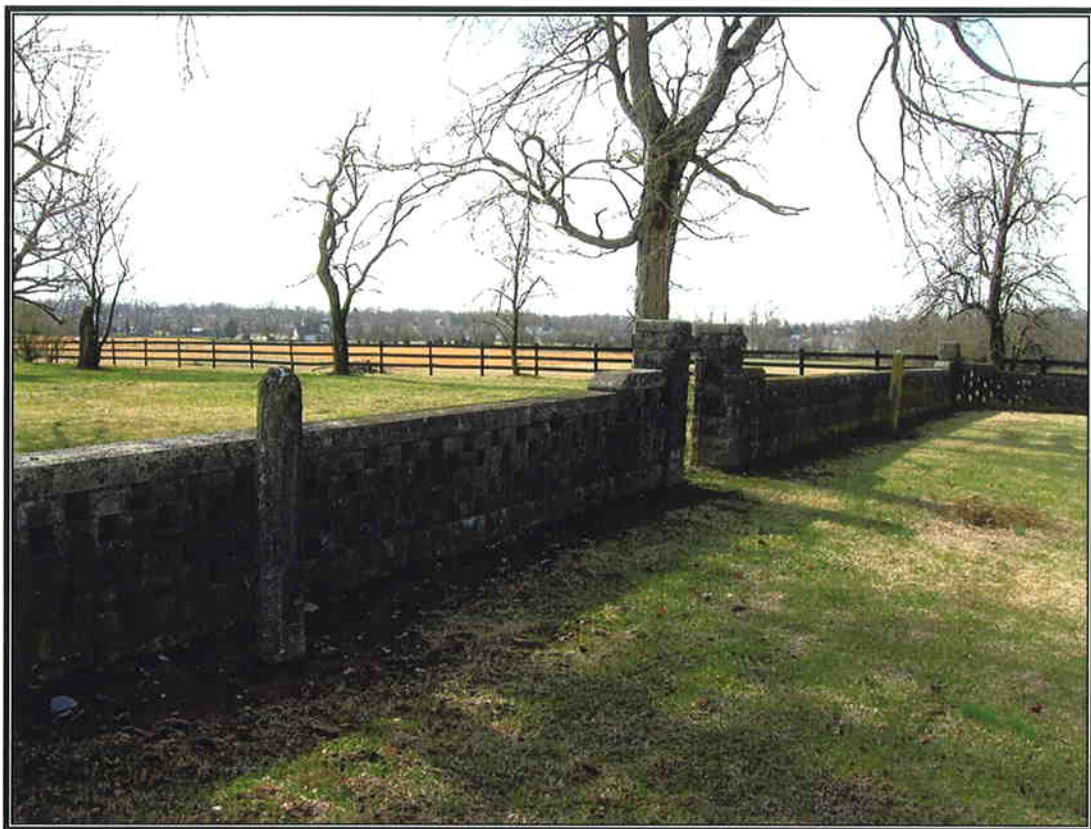
Figure 92. Site 4, Detail of stone fence with hitching posts.

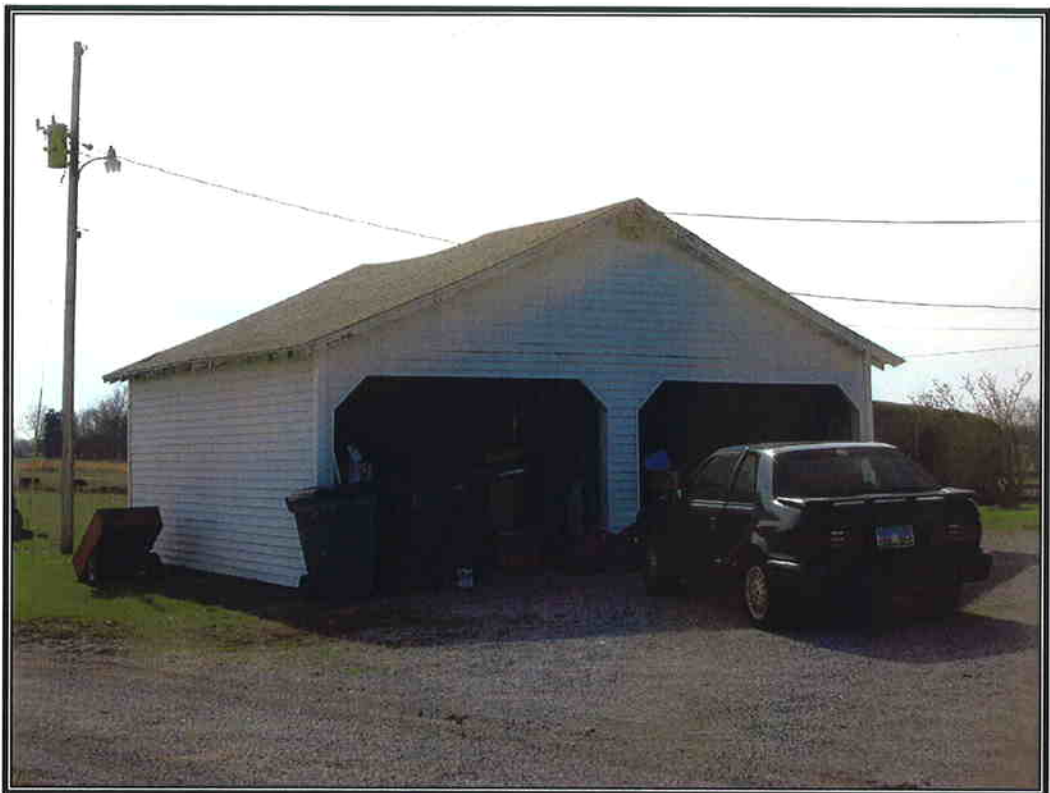
A two-bay, front-gable frame garage is located to the southeast of the house (Figure 94). The garage has exposed rafter tails and is clad in vinyl siding. The roof of the garage is sheathed in asphalt shingles.

Figure 94. Site 4, Two-bay, front-gable, frame garage looking to the south.

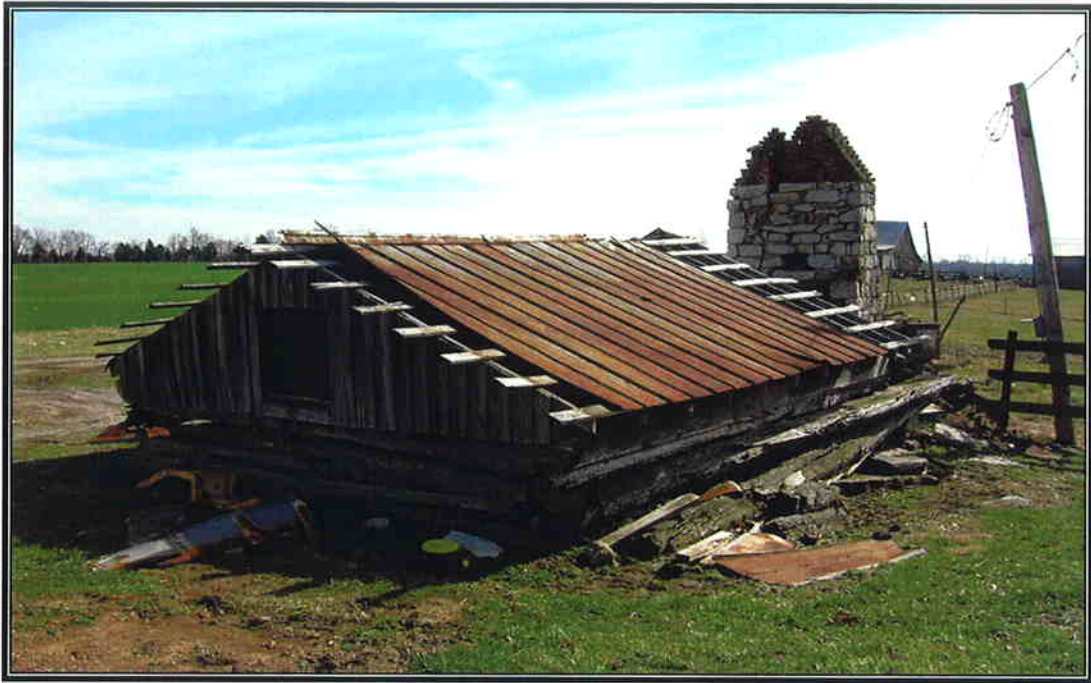
The remains of two log buildings are found to the rear of the house. The first log structure has collapsed with the roof resting on

a few remaining logs (Figure 95). This log structure looks much as it did when surveyed in 1997 (KHC Survey and National Register files). The gable-roof, partially sheathed in prefabricated metal panels and with exposed rafter tails, has its gable clad in board-and-batten siding. The construction method appears to be v-notching. The rear elevation (southeast) has the remains of a chimney (Figure 96). The bottom portion of the chimney is constructed of stone while the remains of the upper portion are constructed of brick.

Figure 95. Site 4, Collapsed log structure with roof resting on remains of logs.

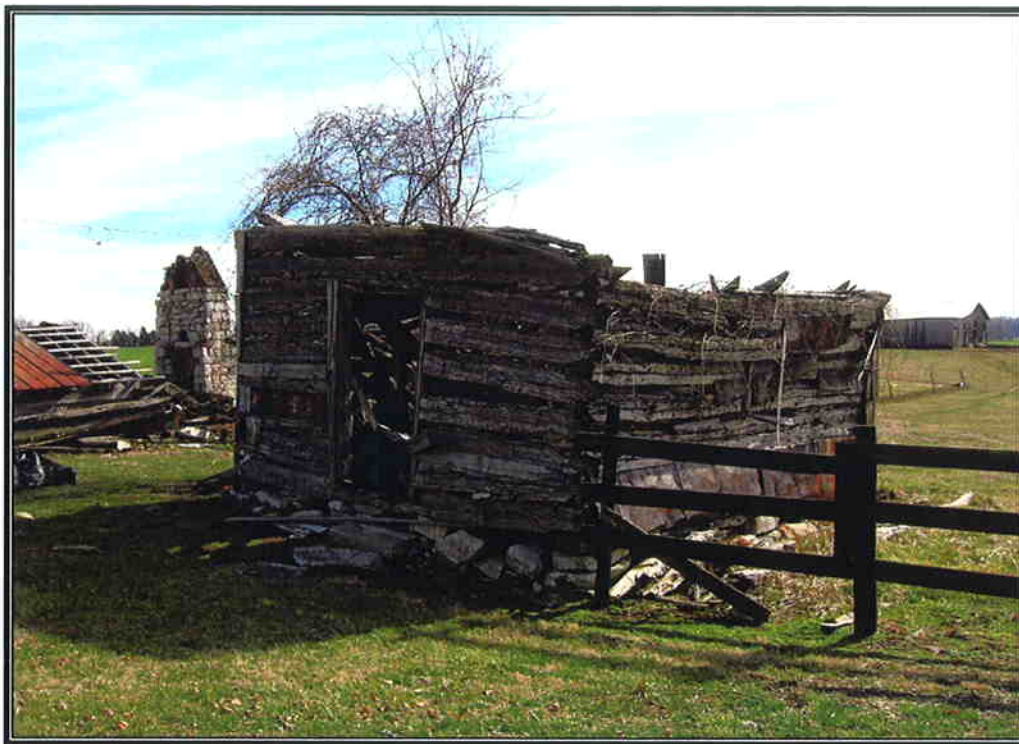
The second log structure is located to the southwest of the previous log structure. This log structure has v-notch construction and an entry on its northwest elevation (Figure 97). The entry has a door constructed of vertical boards. Some stone and wood chinking exists, but the wood chinking may not be historic. The roof has collapsed (Figure 98). The structure rests on a stone pier foundation although stones are found along the ground under the sill. When surveyed in 1997 this log structure retained its roof, and the gable was clad in weatherboard siding (KHC Survey and National Register files).

Figure 97. Site 4, Remains of second log structure looking to the southeast.

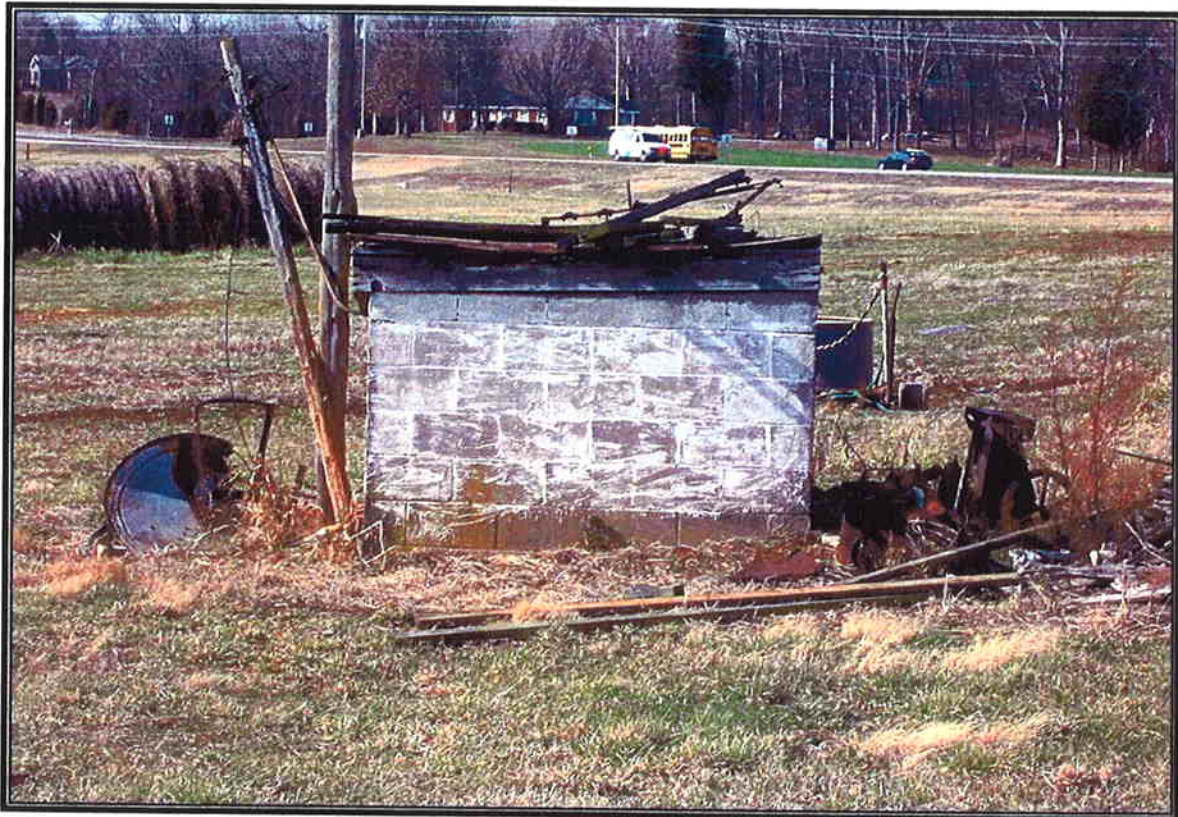
To the rear of the domestic complex is a concrete block well house with a frame roof covering (Figure 99). The roof is sheathed in prefabricated metal panels.

Figure 99. Site 4, Concrete block well pump house looking west.

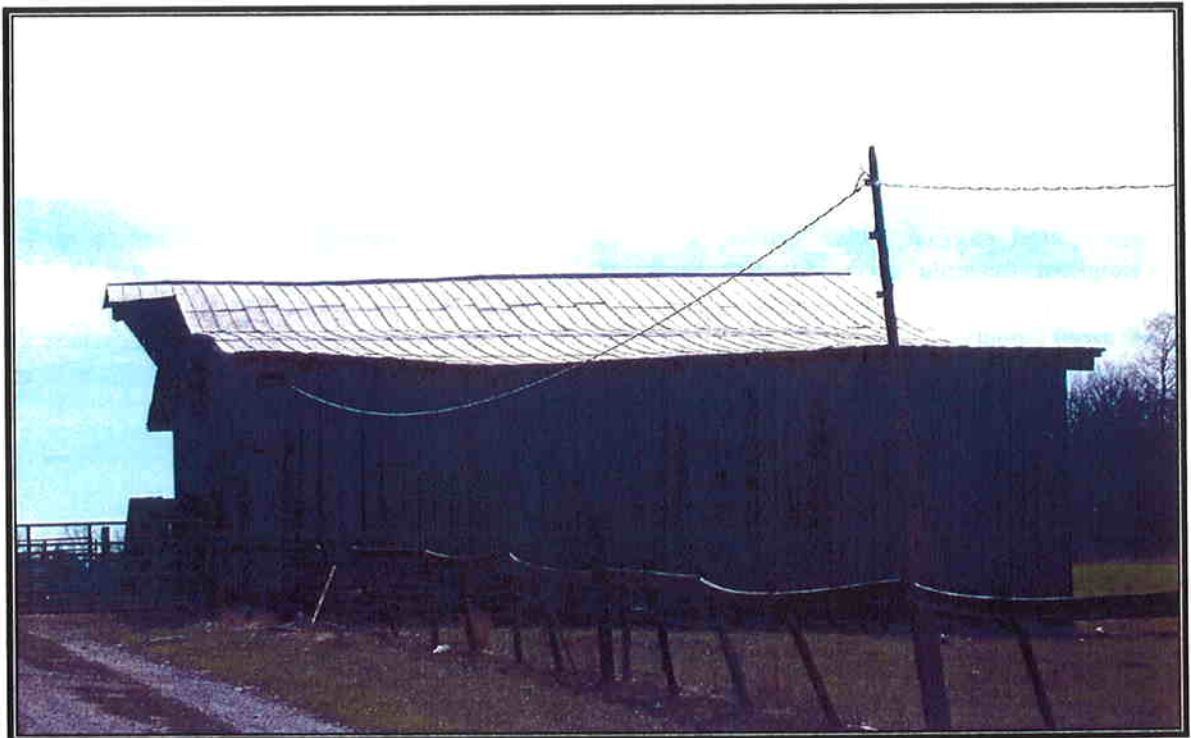
To the rear (southeast) of the domestic complex is a lane leading to two barns (Figure 100). The barn to the southwest appears to be a front-gable livestock barn with an enclosed hay hood (Figure 101). The roof of the barn is sheathed in prefabricated metal panels. The barn is clad in vertical boards. The second barn (to the northeast) may also be a livestock barn with possible shed-roof additions (Figure 102). The roof of the barn is sheathed in prefabricated metal panels. The barn is clad in vertical boards. The outbuildings outside the domestic complex do not appear to be individually significant.

**Figure 101. Site 4, Southwest barn looking to the southeast.**

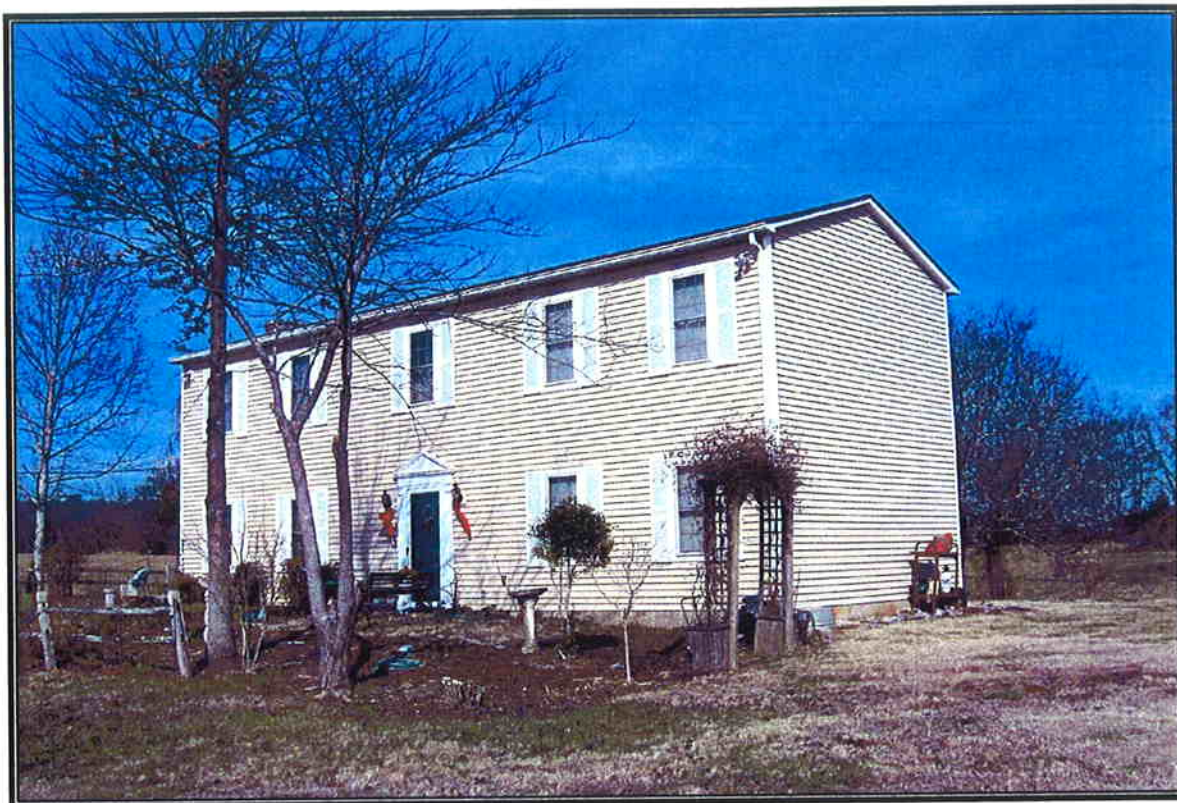
**Description:** This is a two-story, five-bay (w/w/d/w/w), side-gable house with alterations (Figure 104). The house, located at 766 West McLelland Road, is oriented to the southwest. The centered single-leaf entry has a modern door surround with pilasters and a pediment. The windows throughout the house have replacement six-over-six double-hung sashes. The northwest elevation has an exterior brick chimney with shoulders centered along the gable end (Figure 105). A one-story, gable-roof rear ell forms a continuous wall plane with the northwest elevation of the main block of the house. The northwest elevation of the rear ell has a non-historic three-sided projecting bay window. The bay window has non-historic six-over-six double-hung sashes. Perpendicular to the northwest elevation of the rear ell is a gable-roof addition. The southwest elevation of this addition has a single-leaf entry with a non-historic door and paired windows to the left of the entry. A ribbon of three windows with non-historic six-over-six double-hung sashes is found on the northwest elevation of this addition. Another gable-roof addition is located along the rear elevation of the rear ell. The roof is sheathed in asphalt shingles. The house is clad in vinyl siding. Although some stone is visible, the majority of the house appears to rest on a poured concrete foundation. The house may appear on the 1877 atlas of Warren County as the residence of W. H. Jones (Figure 19). This house was previously surveyed in 1978 as a one-and-one-half-story, five-bay log house. The survey form states the house is an enclosed dog-trot form that was clad in weatherboard siding. The house had two exterior gable end chimneys. Photographs of the house on the

previous survey form indicate small, square windows were found to either side of the chimneys in the upper story. Small, rectangular windows appear to be visible in the photographs for the upper floor just below the roofline along the façade (KHC Survey and National Register files). This house appears to be the same as indicated in the previous survey form, although alterations have been made to the house. The roof appears to have been raised to accommodate a full second story. One of the brick gable end chimneys has been removed. The façade fenestration appears different than in the photographs of the previous survey form, as the window spacing is currently more uniform and full size windows have been added to the second story. The small upper story windows to either side of the chimneys have been filled in or enlarged to accommodate full size window sashes.

**Figure 104. Site 5, Two-story, five-bay, side-gable house with alterations (WA-131).**

**NRHP Evaluation:** Not Eligible. Modifications to this house have compromised the historic qualities of design, materials, workmanship, and feeling necessary to convey its significance. Modifications to the house include raising the upper half-story to a full second story, replacement windows, vinyl siding, removal of one of the gable end chimneys, replacement doors, non-historic door surround, and rear additions.

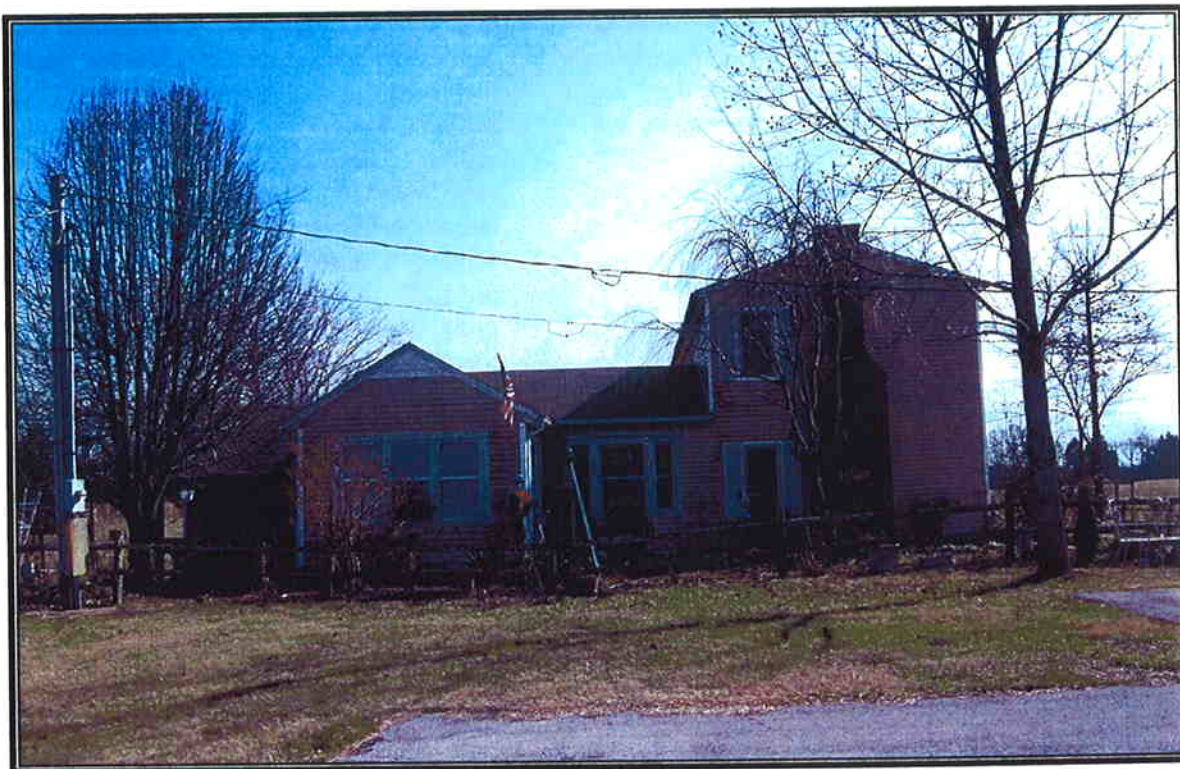
**Figure 105. Site 5, Northwest elevation of the house.**

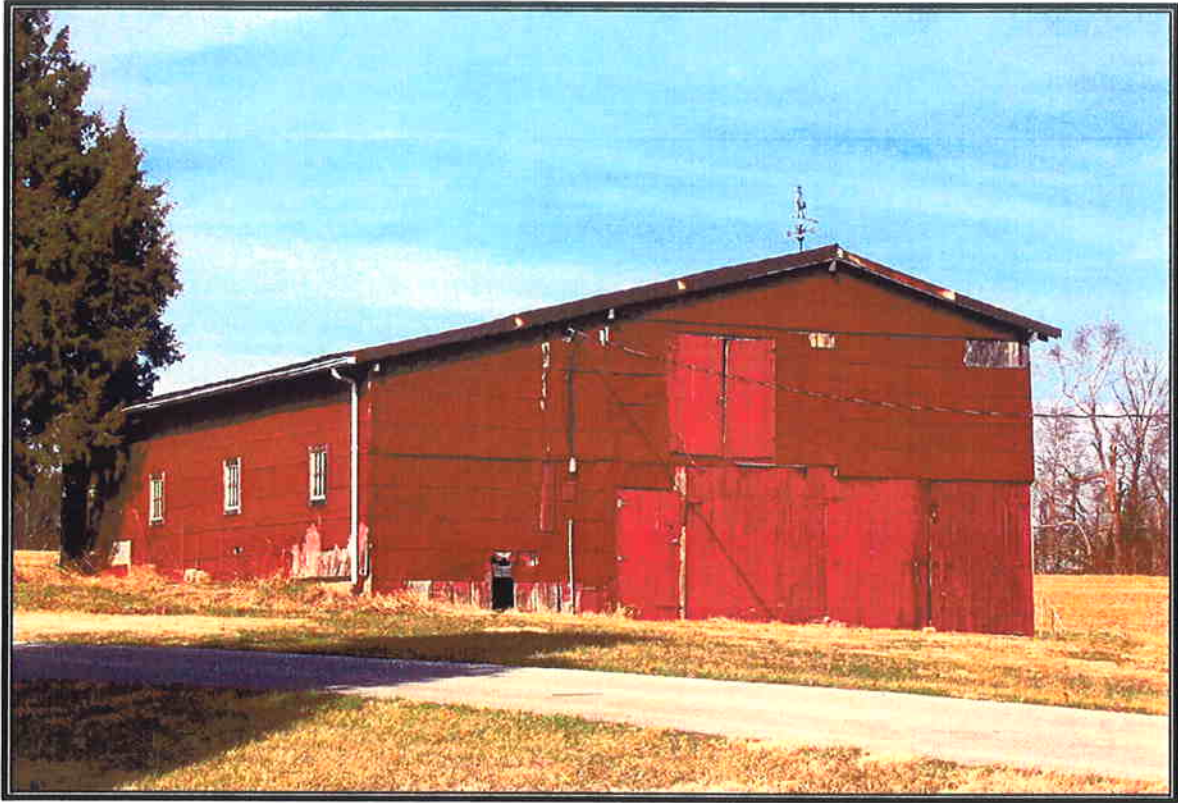
Northwest of the house is a front-gable barn with three entries along its southeast elevation: two double-leaf entries and a single-leaf pedestrian entry (Figure 106). The entries are constructed of vertical boards. The southwest elevation of the barn has a shed-roof addition, probably historic, that forms a continuous roof line with the original portion of the barn. This addition has four windows along the southwest elevation with six-light sashes. The southwest elevation rests on a poured concrete foundation. The roof is sheathed in prefabricated metal panels. The barn is clad in rolled asphalt with a brick pattern over vertical boards. This barn appears on the 1952 topographic map (Figure 25).

**Figure 106. Site 5, View to the north of barn associated with the house.**
